## TEST REPORT

Report No.: A2210367143101001C

Sample name Stainless steel jewelry

## TEST ITEM: SALT SPRAY TEST

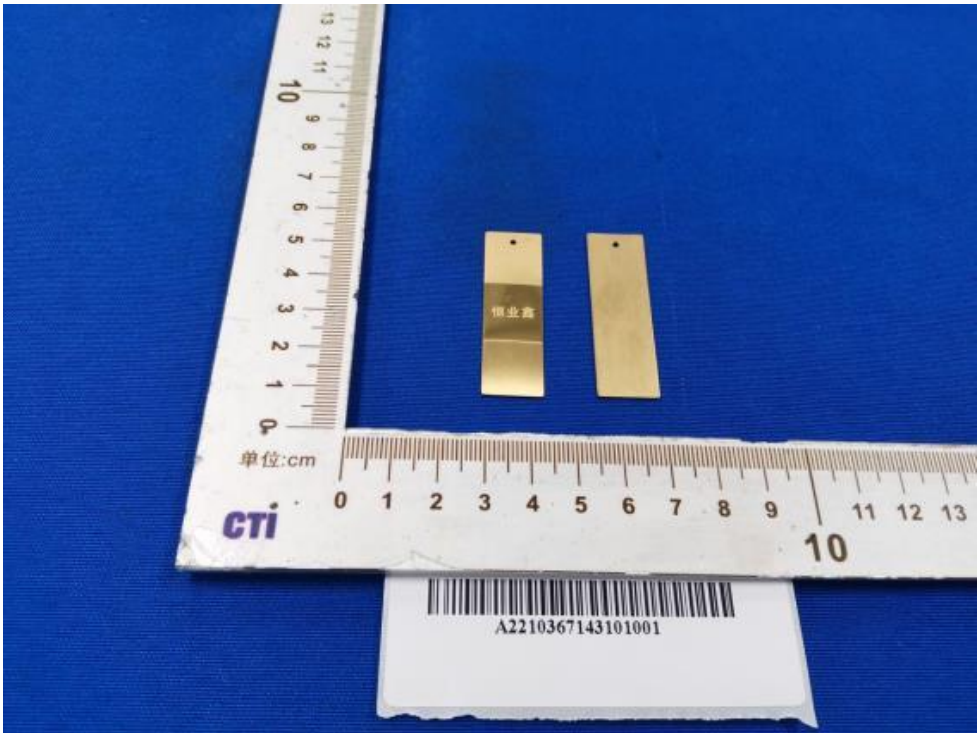
A2210367143101001

SAMPLE PHOTOGRAPH

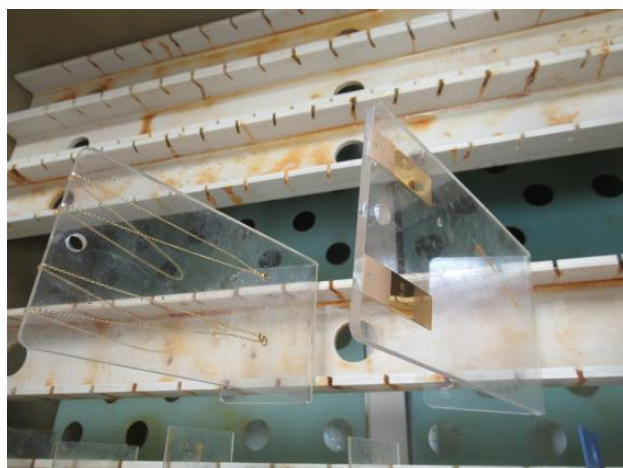
A2210367143101001

### TEST PHOTOGRAPH

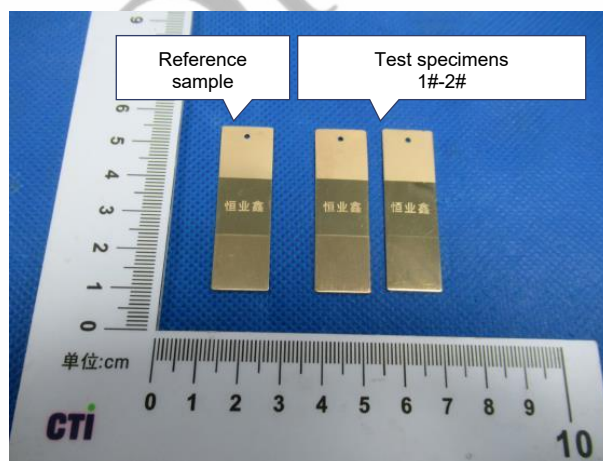
### SAMPLE PHOTOGRAPH AFTER TESTING

| Sample No. | Test specimen | Appearance (visual inspection) |
|---|---|---|
| A2210367143101001 | 1# | No visible corrosion |
| A2210367143101001 | 2# | No visible corrosion |
